# TECHNICAL REPORT TR-2231-ENV

## COST AND PERFORMANCE REPORT ADVANCED PASSIVE ACOUSTIC LEAK LOCATION AND DETECTION VERIFICATION SYSTEM FOR UNDERGROUND FUEL PIPELINES

## **ESTCP Project: CP-9904**

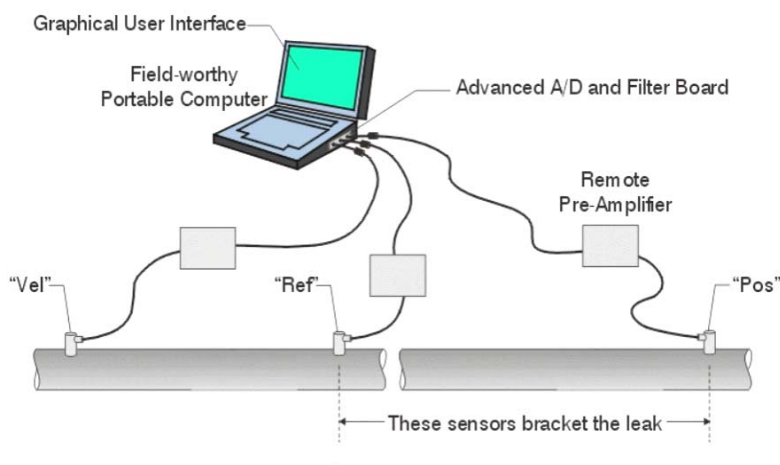
**Figure 1. Schematic of the PALS.**

As shown in Figure 1, PALS consists of three cylindrical acoustic sensors (1.5 in. in diameter and 3 in. in height), three small pre-amplifiers (6 in. x 3 in. x 2 in.), and a field-worthy notebook computer having a data acquisition card. The pre-amps need to be located in close proximity to the sensors; typically, the pre-amps are within 10 ft of the sensors. The cables connecting the pre-amps to the data acquisition card in the computer can be up to a thousand ft in length. Communication between the sensor-pre-amp subsystem and the computer could also be accomplished by wireless communication, but this would be substantially more expensive.

The sensors are normally attached with epoxy directly to the pipe wall or to the end of a flange connecting two sections of pipe. The sensors can also be attached to a blind flange at the termination of a pipe section. The sensors can also be mounted on the pipe using petroleum jelly to obtain good communication between the pipe and the sensor. This attachment procedure was used when the sensor needed to be attached to the end of a staff to gain access to the pipe wall. Other mounting techniques (e.g., magnets, clamps) can be used if implemented without grounding the system. There are two requirements for mounting the sensors. The first is that the sensors (accelerometers) be attached to the wall in such a way that any acceleration in the pipe produced by the leak signal be communicated to the sensor. Second, it is important that the sensors not be grounded to the pipe because the epoxy and the petroleum jelly prevent grounding due to the fact that there is no metal to metal contact between the pipe and the sensors.

The Pipeline Acoustic Leak-location System (PALS) is an innovative technology that was developed for the reliable location of fuel leaks in underground, pressurized fuel pipelines (Figure 1). It is an outgrowth of the previous work performed by EPA [1-3], DOE [4-8], and SERDP [9-15].

Each sensor measures the acoustic signal generated by the flow through a hole in the pipe. A pair of sensors called the Position (Pos) and Reference (Ref) sensors brackets the leak and determines the location of the leak relative to the Reference sensor. A second pair of sensors, that do not bracket the leak, is used to measure the speed of propagation of the acoustic signal in the pipe. The propagation speed is measured using the Velocity (Vel) and the Reference sensors. For the leak to be properly located, the distances between the sensors must be known-since the measurement made by the PALS determines the location relative to the Reference sensor for the sensor configuration (Vel-Ref-Pos). These distances and this sensor configuration must be entered into the PALS software before a measurement can be taken. A second measurement configuration can also be used in which both the Vel and Pos sensors are located to the left or right of the Ref sensor (Ref-Vel-Pos). The Ref-Pos sensors still bracket the leak, while the Ref-Vel sensors do not. A leak-location measurement can take as little as 2 to 5 minutes to complete.

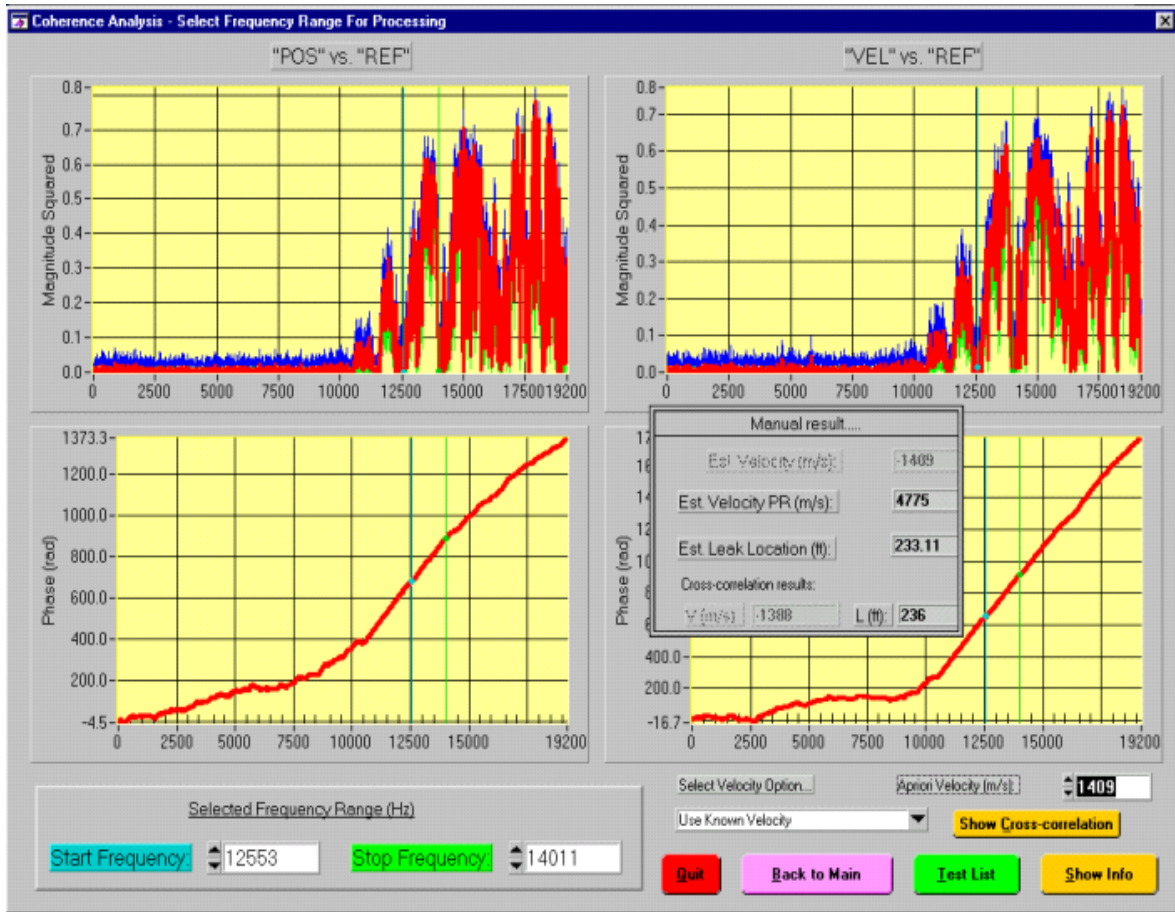
Figure 2. Output of the PALS.

An example of the output of the coherence function ( $\gamma^2$ ,  $\phi$ ) is shown in Figure 2 for a 1.9 gal/h-leak through a 0.01-in.-diameter hole in the line at a line pressure of 70 psi. The results are summarized in Table 1. The distance between the Pos-Ref and the Vel-Ref was 360.0 ft and 137.3 ft, respectively. The reference sensor was mounted on the blind flange at the top of the pipe. The presence of the leak signal is clearly seen in Figure 2 for frequencies above 10 kHz for both the Pos-Ref and the Vel-Ref coherence functions. Values of  $\gamma^2$  are greater than 0.6 and are clearly greater than the values of  $\gamma^2$  outside the leak signal frequency band (frequencies less than 10 kHz). While the phase  $\phi$  is highly linear, the phase slope,  $d\phi/df$ , changes slightly with frequency in the vicinity of the three peaks in  $\gamma^2$  found at frequencies of 13.5, 15.0 and 18.0 kHz. The analysis for leak location was performed between 12.6 and 14.0 kHz. As shown in Table 1, PALS located the leak to within 0.4 ft (or 0.1% of the 360.0-ft Pos-Ref separation distance). The PALS location was 233.1 ft from the Ref sensor, and the actual location of the leak was 233.5 ft. A propagation velocity of 1,409 m/s was measured and used in the analysis.

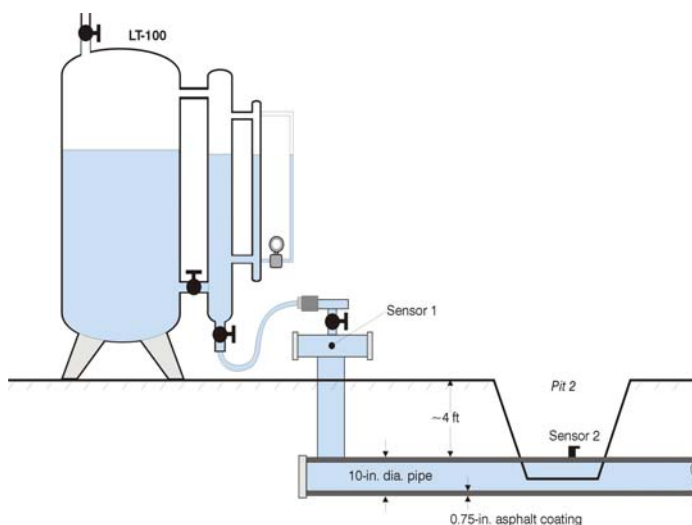
**Figure 3. Schematic of the Constant-Pressure, Volumetric Leak Detection System.**

Four DEM/VALs were planned and conducted to address the objectives presented in Section 3.2. In each DEM/VAL, the line was pressurized with the volumetric measurement shown in Figure 3. This volumetric system, which is a prototype of the Vista LT-100 leak detection system, is capable of keeping the line at constant pressure and measuring the total volume and leak rate to a leak point [28, 29]. The system was attached at one end of the line, and the tests were performed with pressures ranging from 0 to over 150 psi were used and leaks ranging from 0 to over 20 gal/h. A detailed description of, and a figure illustrating, the configuration of each of the pipelines used in the DEM/VALs are given in Appendix C of the Final Report [18].
